# Lateral Migration of the Middle Sacramento River California

U. S. GEOLOGICAL SURVEY

Water-Resources Investigations 77-43

*Prepared in cooperation with the  
California Department  
of Water Resources*

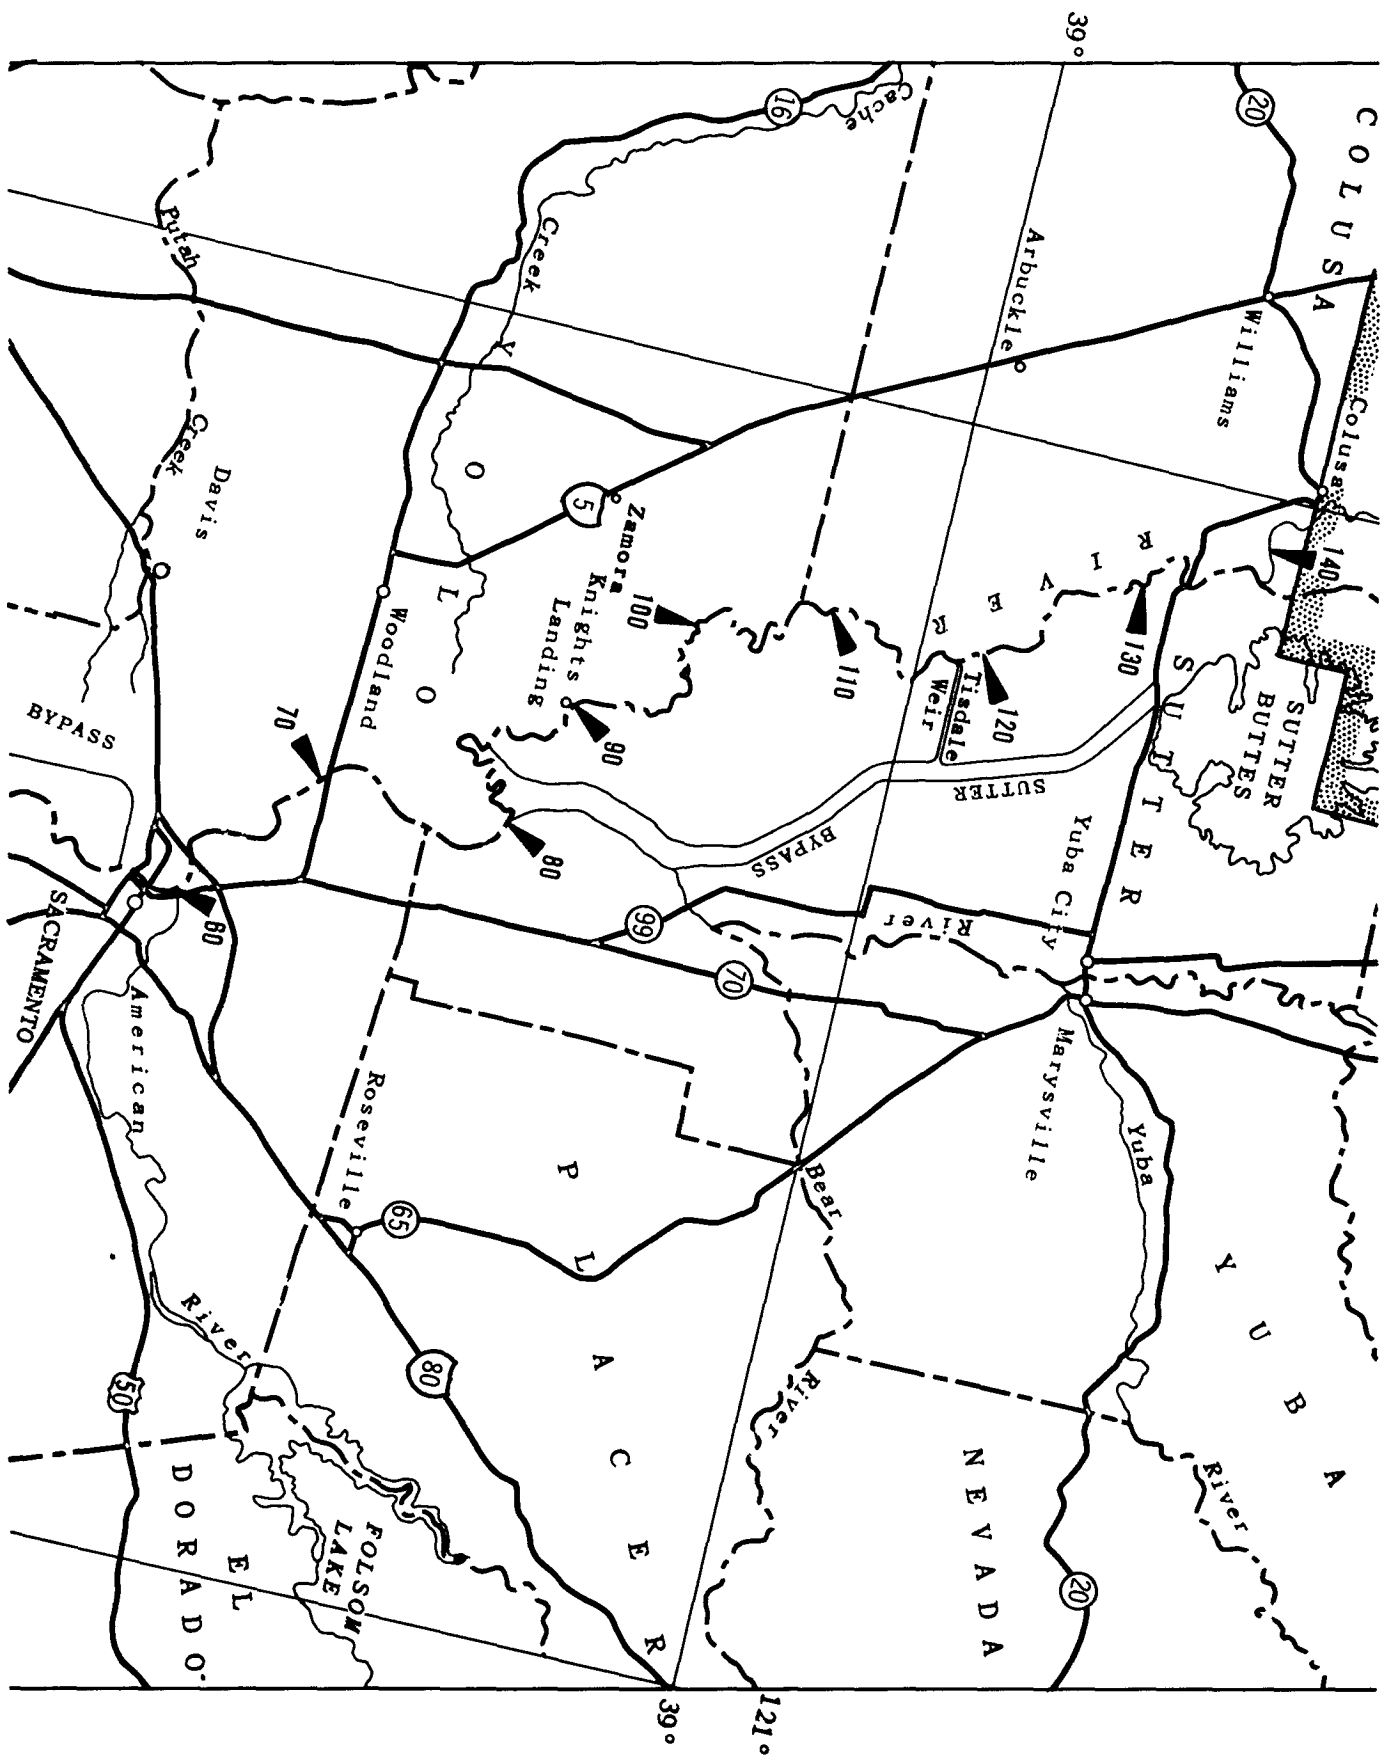
FIGURE 2.— Location of study reach of Sacramento River, showing River Miles (RM).  
(Continued on following pages.)

A general description of the Sacramento River has been given by Bryan (1923) and by Olmsted and Davis (1961). For most of its course, the Sacramento River flows through the Sacramento Valley, a structural trough whose nearly flat surface is underlain by deposits brought in from the adjoining mountains by the river and its tributaries. Bryan (1923) considered that the river enters the Sacramento Valley at the lower end of Iron Canyon (fig. 2).

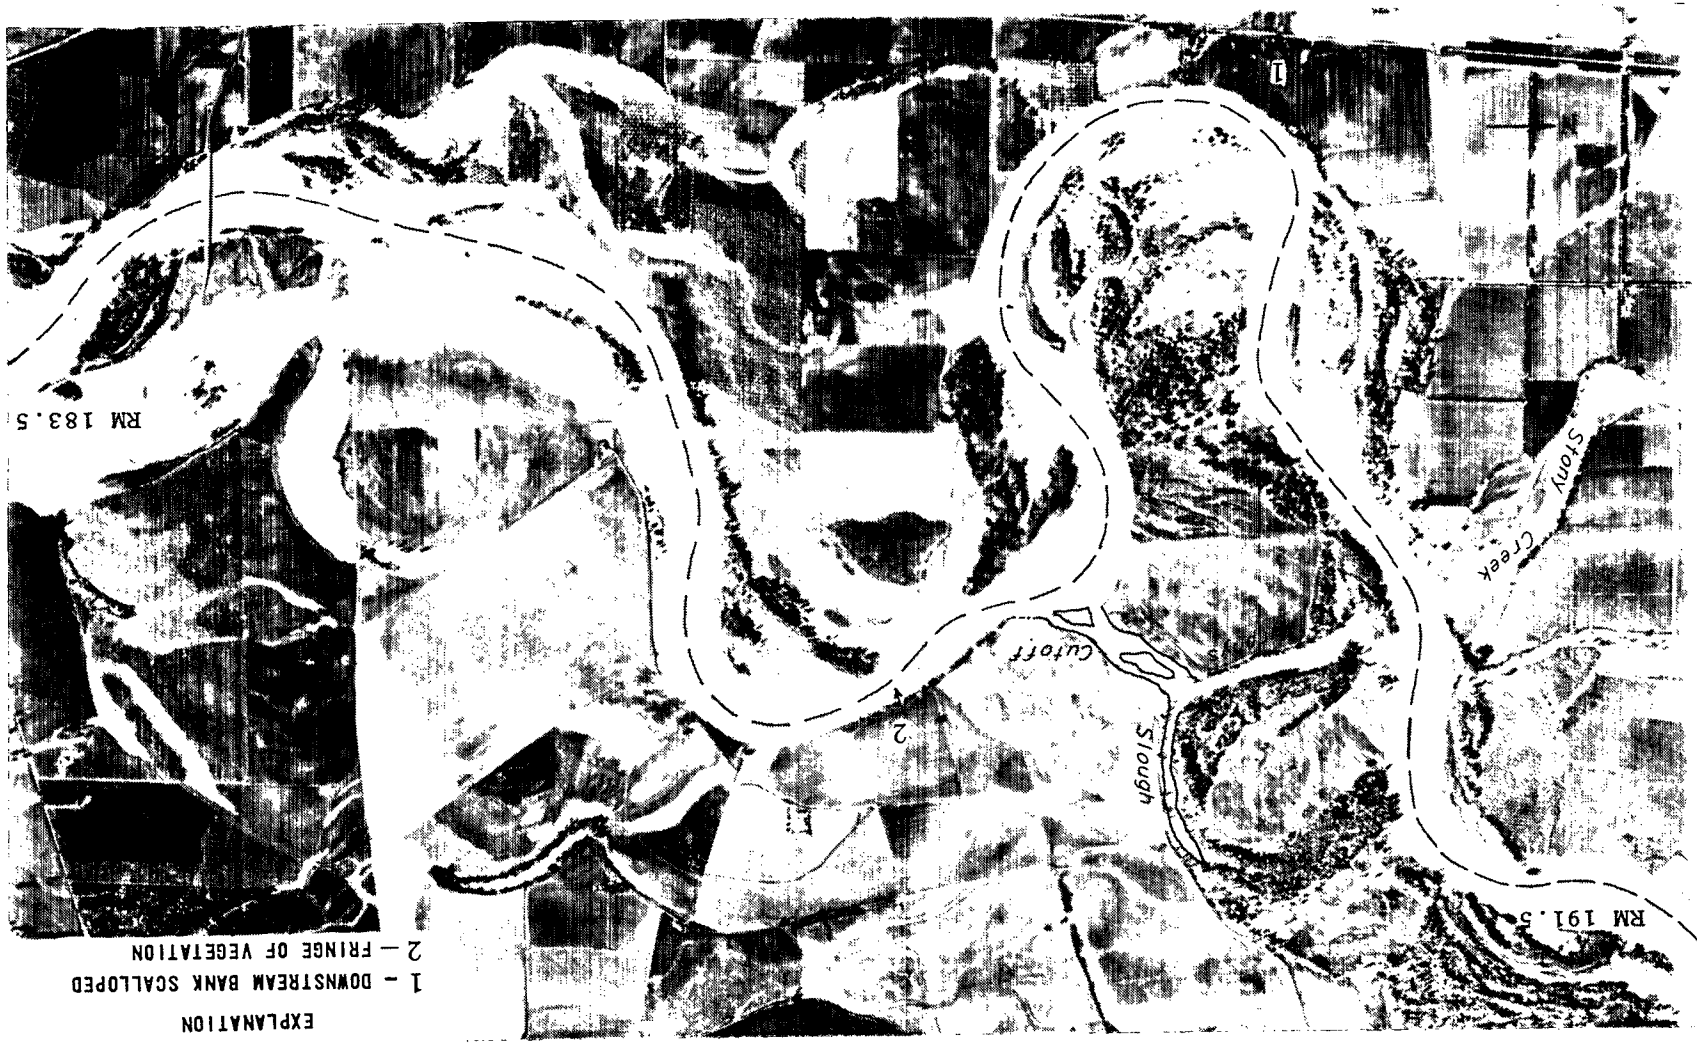
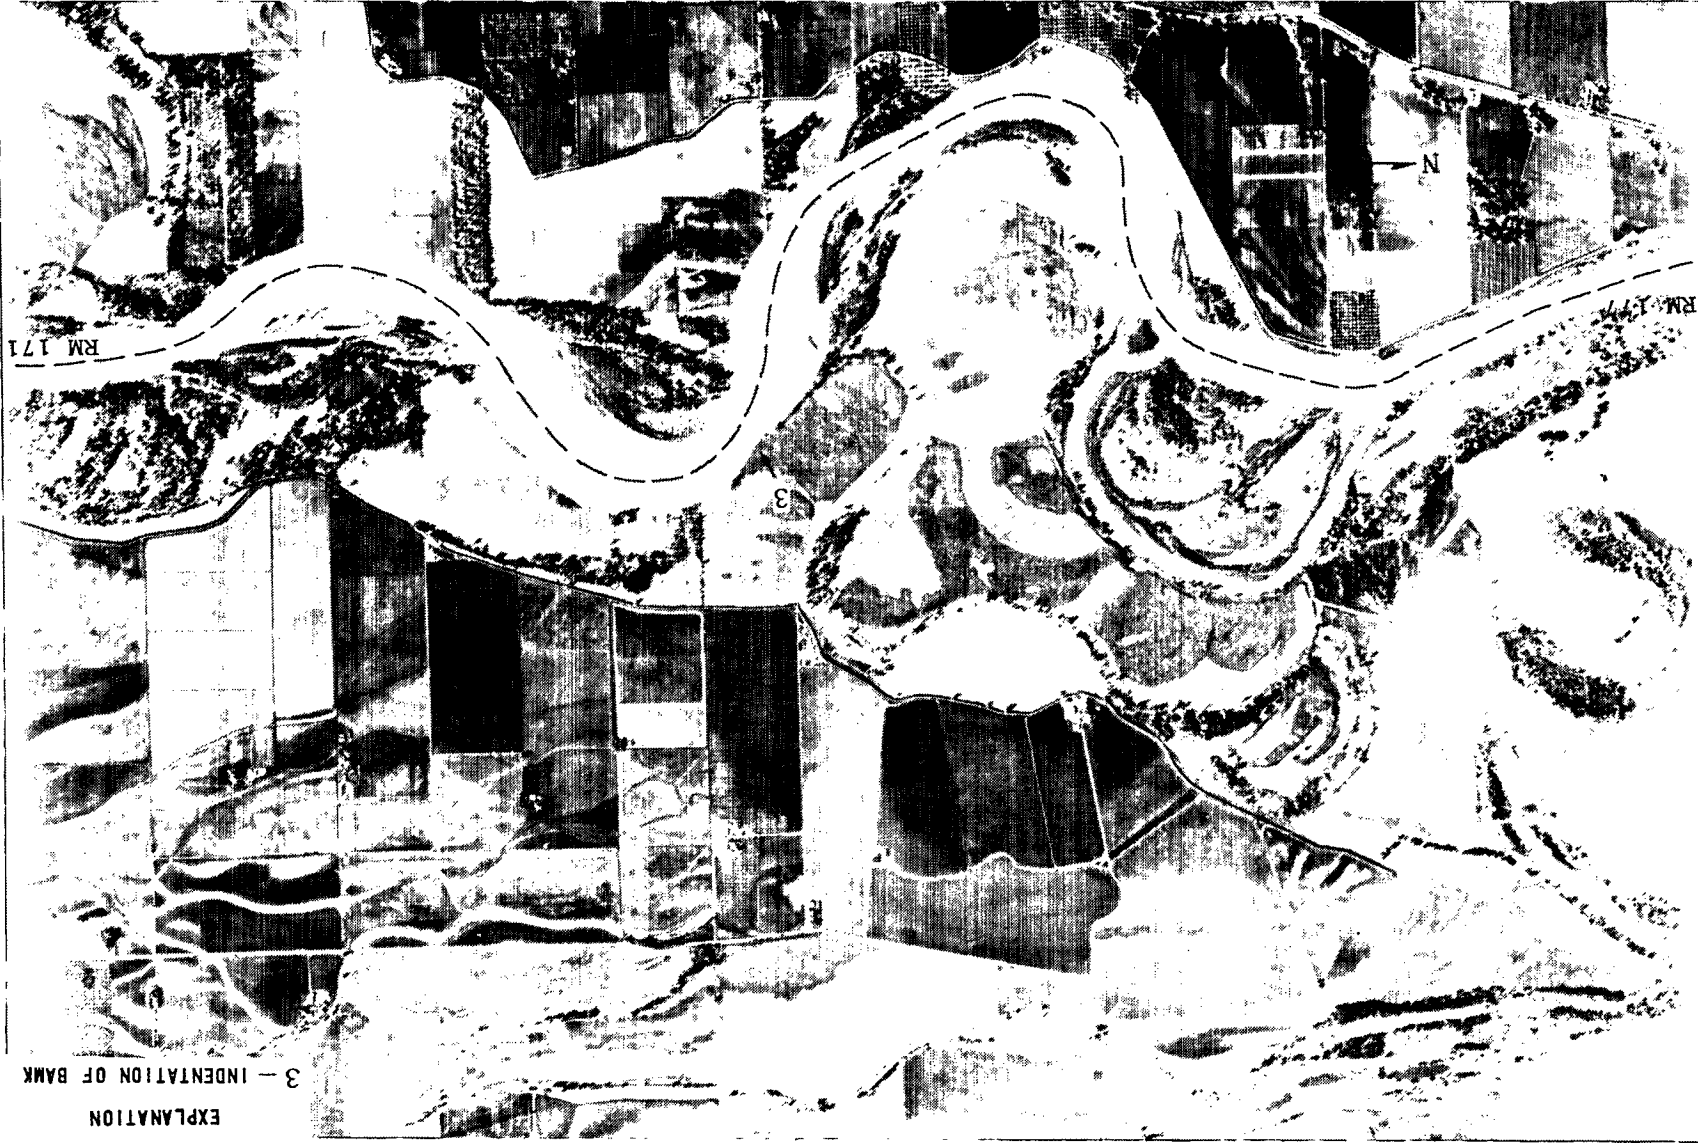
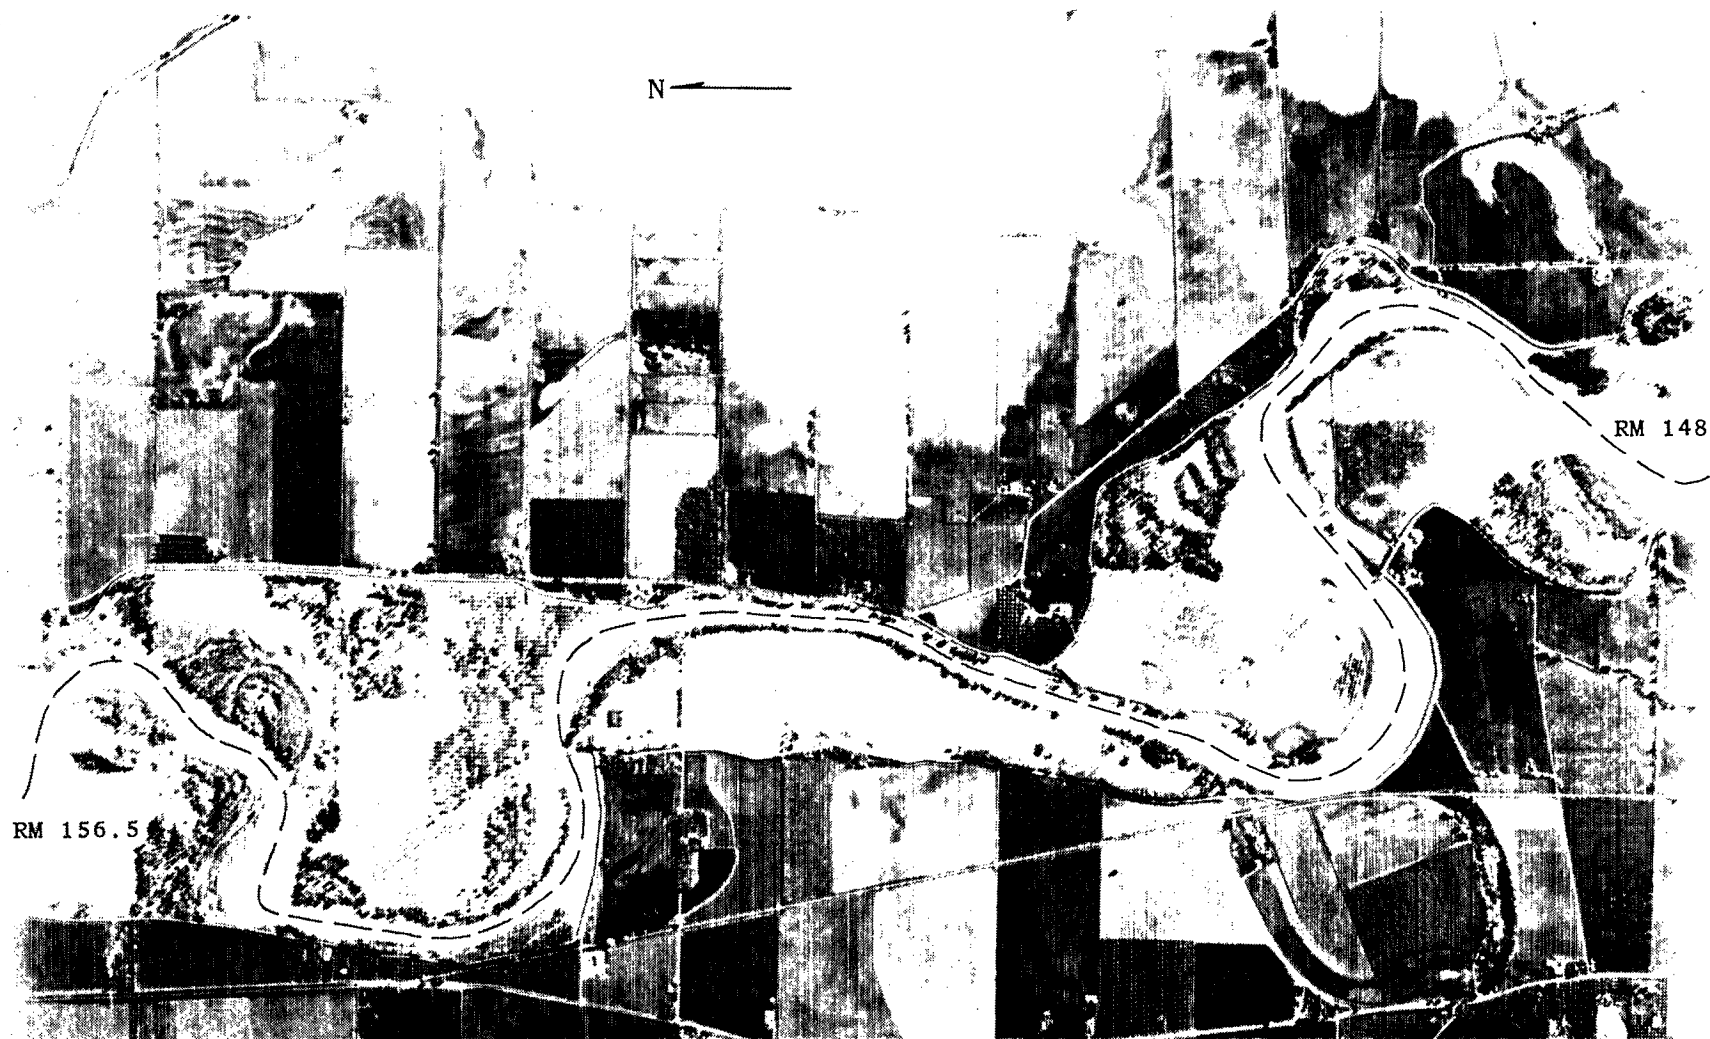
A. RM 191.5 - 183.5

FIGURE 4.— Vertical aerial photographs of the Sacramento River at flood stage, January 21, 1974

B. RM 177 - 171

C. RM 156.5 - 148

D. RM 146 - 136

From the channel and the valley centerline plots, the sinuosity of each reach was computed (table 4). The sinuosity for reaches 1-7 (figs. 7-13), considered as a whole, decreased steadily from 1.56 in 1896 to 1.35 in 1974, or to 1.29 in 1974 if the cutoff at Murphys Slough (fig. 7B) is considered to be the main river channel. The sinuosity of reach 3 (fig. 9A) decreased from 2.12 in 1870 to 1.16 in 1896. Sinuosity of other reaches for the period 1867-72 is uncertain, because the river is crudely represented on the relevant land-plat surveys. Reach 3 is exceptional because the river was accurately surveyed in T. 19 N., R. 1 W.; the river position on the land-plat of this township corresponds closely with the position of now-abandoned meander loops on aerial photographs (fig. 4B).
